## Be careful what you drive over

Propshaft Length

## Prop-shaft Alignment

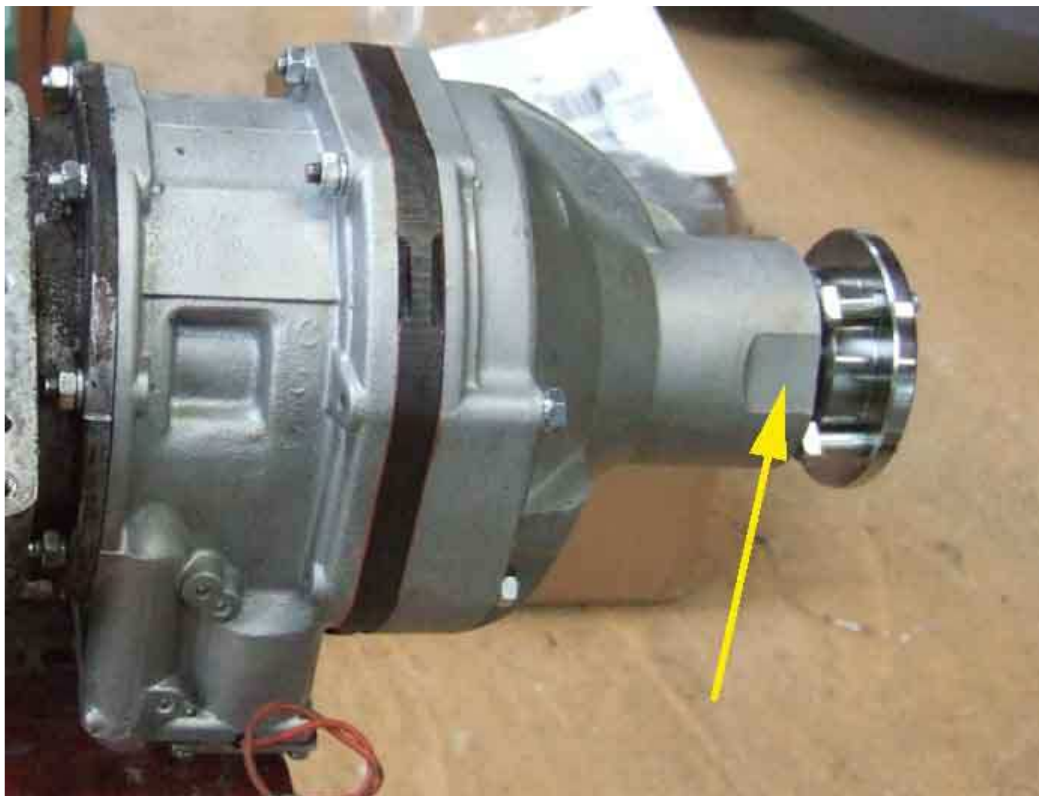
The flat on the OD casing on all models, which allows the bolts to be removed from the V8 flange while fitted.

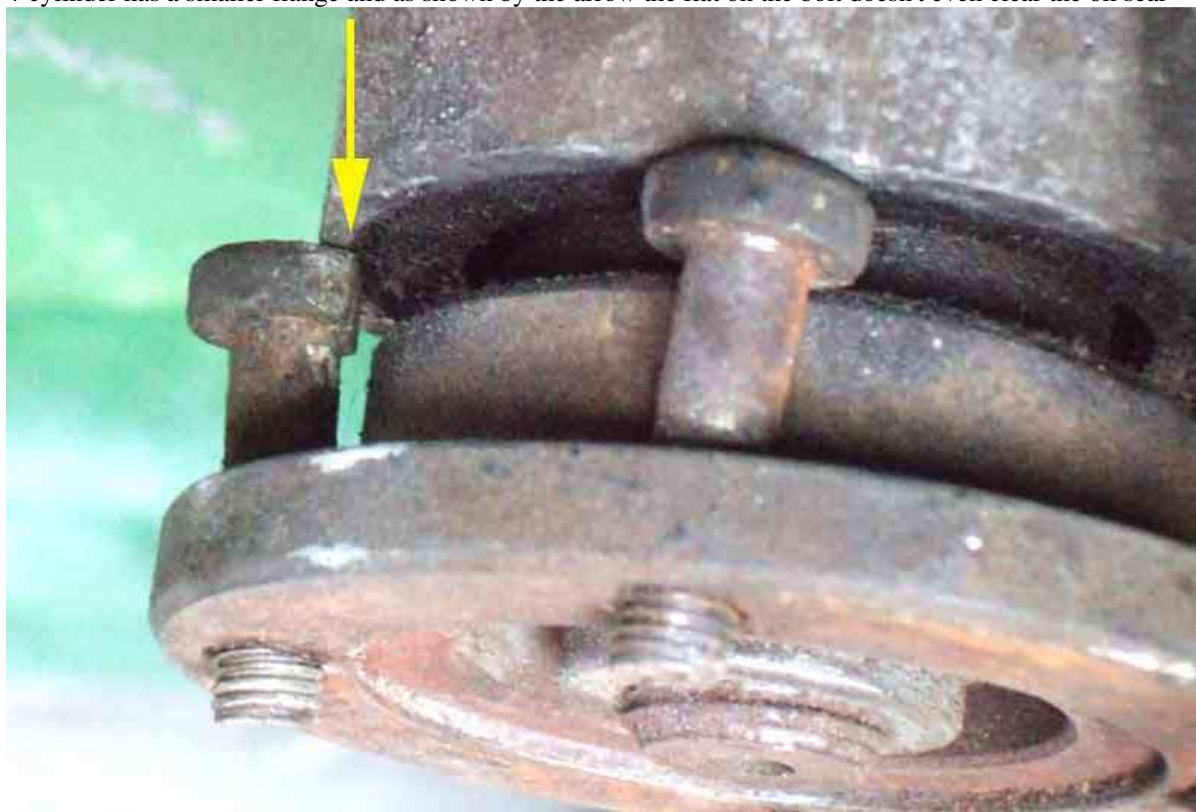
The 4-cylinder has a smaller flange and as shown by the arrow the flat on the bolt doesn't even clear the oil seal

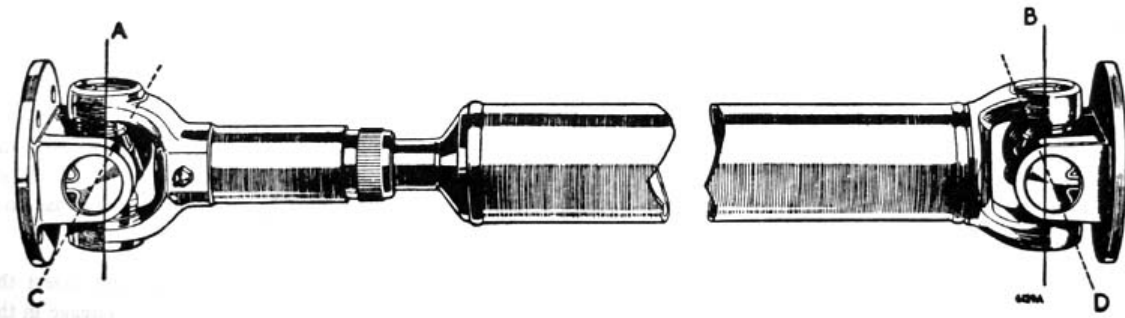
Yoke orientation

When the splined shaft is assembled to the drive shaft it is essential to see that the forked yokes on both shafts have their axes parallel to each other. In other words, the yoke (A) must be in alignment with the yoke (B), and the flange yoke (C) must be in alignment with the flange yoke (D)

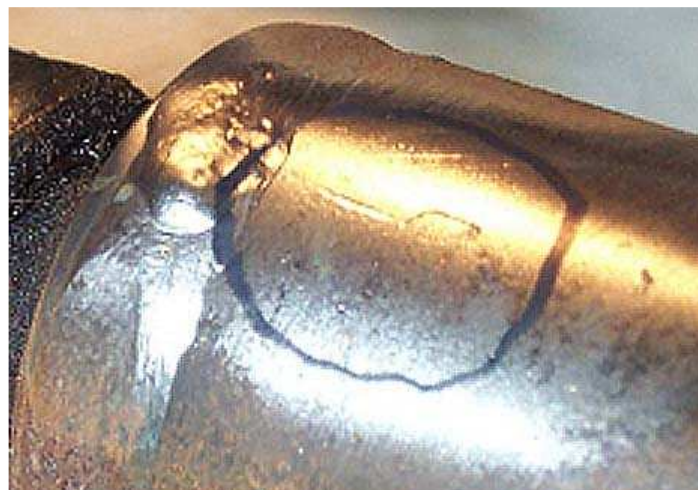
Fletcher's first photo enhanced as best I can. I can just make out an arrow 'shaft' and one half of the 'flight' but no head - a typical mis-stamping.

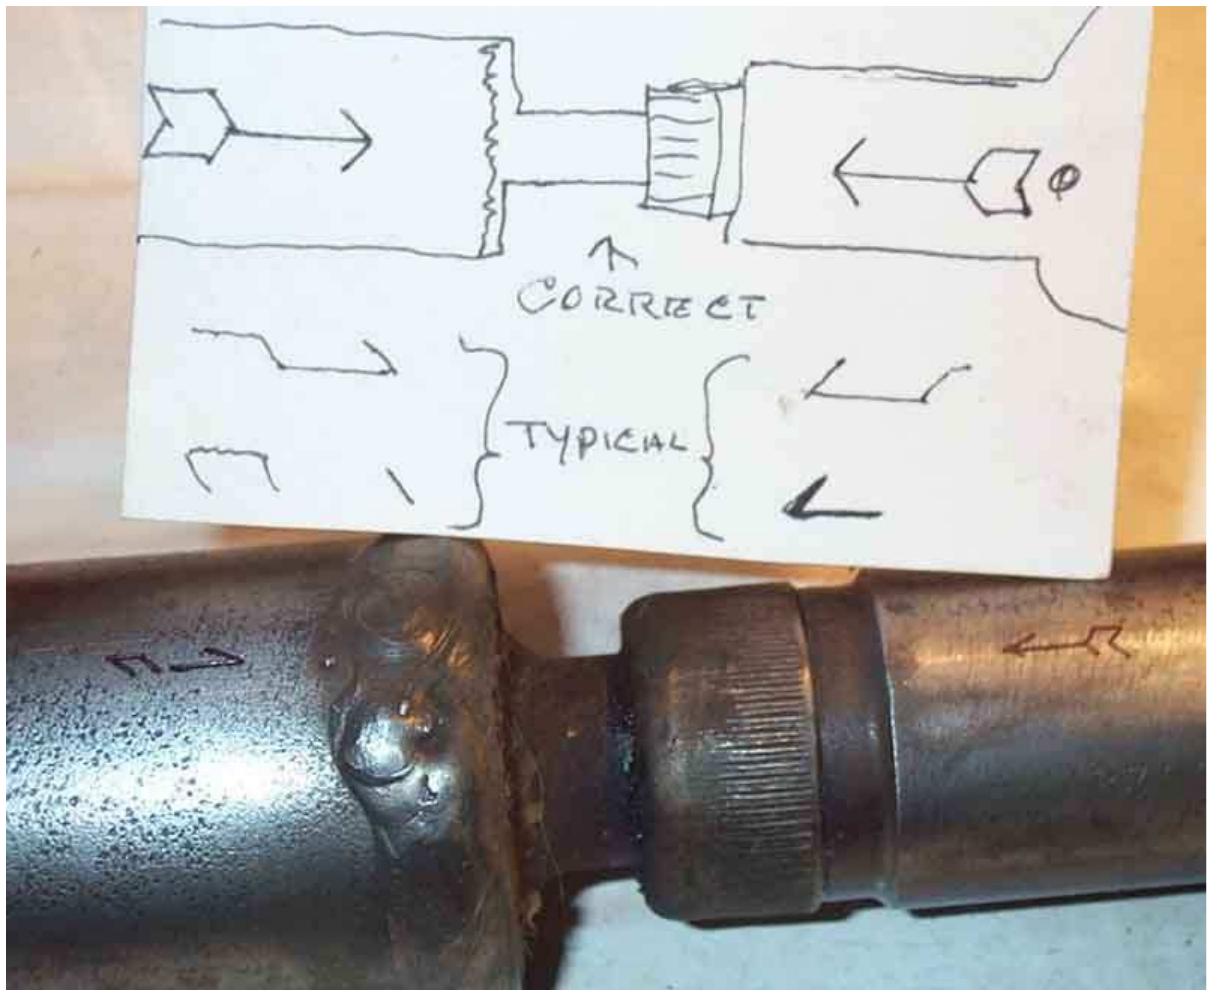
Fletcher's 'best' markings, together with some examples of the poorly stamped markings you are likely to find in practice.

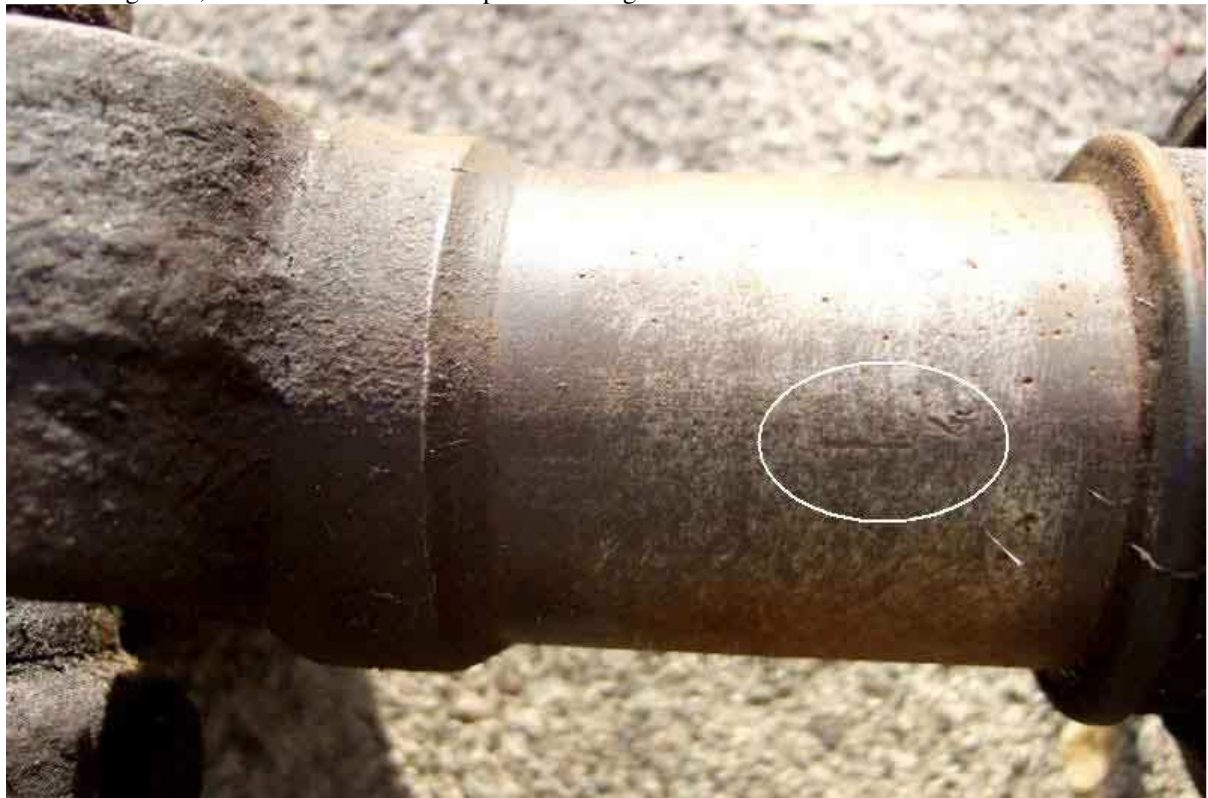
My old V8 shaft, two lines on the yoke, which **could** be the shaft and half of a detached head, but nothing on the tube. These are also sort of but not exactly in-line with one of the arms of the yoke, and not between them as on Fletcher's so could be nothing at all, but are close to the example bottom right above.

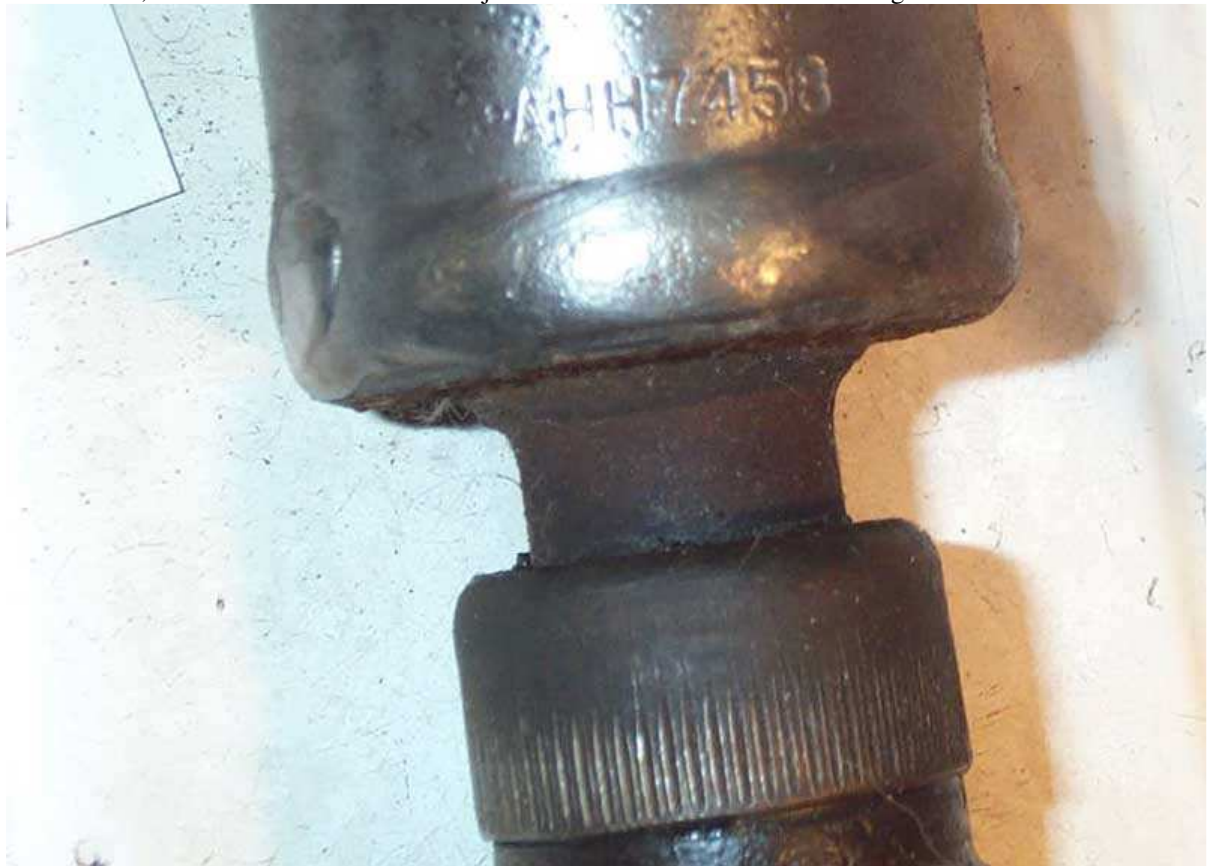
Another of Fletcher's photos this time showing what appears to be a part number stamped into the end of the tube of a banjo axle non-OD shaft. However AHH 7458 is the part number of the little plastic clip that holds the straight end of the sun-visor rod, the correct number for the banjo non-OD shaft from the Parts catalogue is AHH 7488.
