## Body and Fittings

### Quarter-panel Replacement

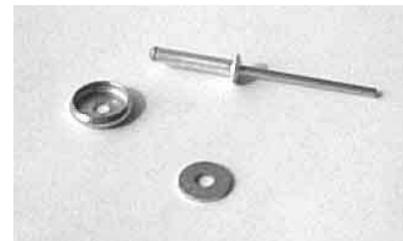
Fitting kits are available containing the full complement of pop-rivets with cup-shaped washers attached and six studs and nuts, sometimes washers too sometimes not, as shown in this picture.

pop-rivets don't expand behind the holes but inside. I bought some long-reach rivets and transferred the cup-shaped washers over, then used an appropriately-sized washer behind the panel, so not only did the pop-rivet go through a skim of filler two panels and a washer, but it also secured firmly behind the washer no matter how large and irregular the hole was. The cup-washer removed from the original pop-rivet, a long-reach rivet, and a suitable washer can be seen in the picture.

Drill out the old fasteners, which are held on with aluminium pop-rivets of about 2mm in diameter. You may have to hold the cup-shaped washer in a pair of pliers to stop it spinning round with the drill.

However I have found that if a panel has been replaced from the trim down there can be a double-thickness of metal plus filler, and the pop-rivets as supplied are not long enough to go right through. Consequently they expand inside the hole and can work loose, sometimes when trying to refit the trim. Also if a panel has been skimmed, painted and drilled a couple of times or more the holes can become large and uneven, so again the
