Engine

Last updated 31-Dec-2017

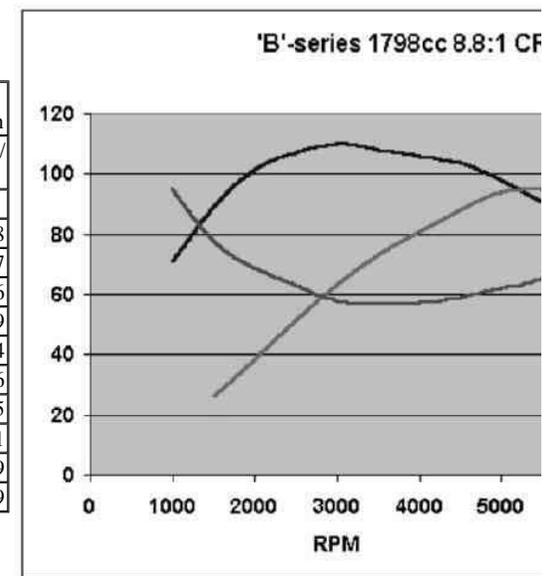
Data for the following BHP, Torque and fuel consumption curves cropped up on the MG mailing list recently, makes interesting reading. Originally published in 'The Motor' September 26th 1962, subsequently reprinted in a 'Brooklands' book - "MG Cars 1959-1962" - and posted to the mailing list by Blake (aka [Bullwinkle](#)). Note these figures were taken at full throttle with an engine brake to obtain the required rpm. The fuel consumption figures have been multiplied by 100 to fit the vertical axis.

RPM	Torque (Lb.Ft.)	BHP	Fuel Consumption	
			Pints/BHP/hr	Pints/min.
1000	71		0.95	
1500	89	26	0.78	0.338
2000	101	38	0.69	0.437
2500	107	51	0.63	0.536
3000	110	63	0.58	0.609
3500	108	73	0.57	0.694
4000	106	81	0.575	0.776
4500	104	88	0.59	0.865
5000	98	94	0.62	0.971
5500	91	95	0.65	1.029
6000		92	0.73	1.119
